How Does Urban Development Impact the Duck Creek Watershed? Juneau, Alaska

John Wahl Department of Natural Sciences, EDGE Program/ ED 593-J01 University Alaska Southeast, Juneau, Alaska 99801, June 15, 2007

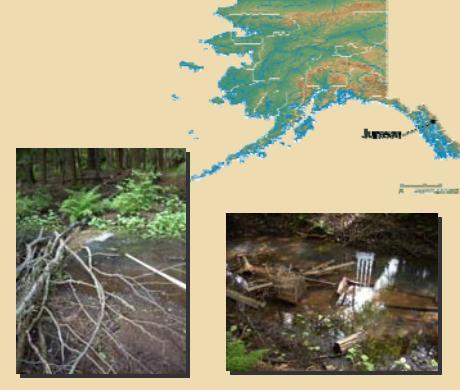
Fig. 7 & 8 Natural and urban debris disrupting water flow

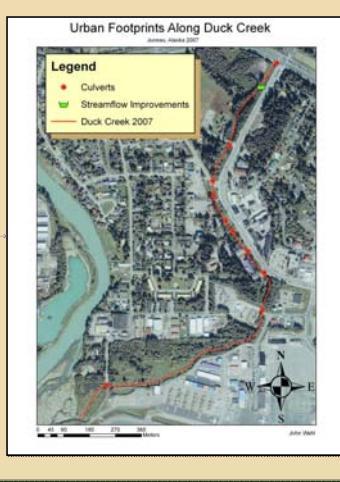
Fig. 6 (Left) Stream-flow improvements along Duck Creek
