The Effect of Storm Drain Run-off on Total Aerobic and Coliform Bacteria Blooms in Cottonwood Creek, Wasilla, AK

**Megan Bowker and
Blake Wangberg
Colony High School**

EDGE Symposium Progress report

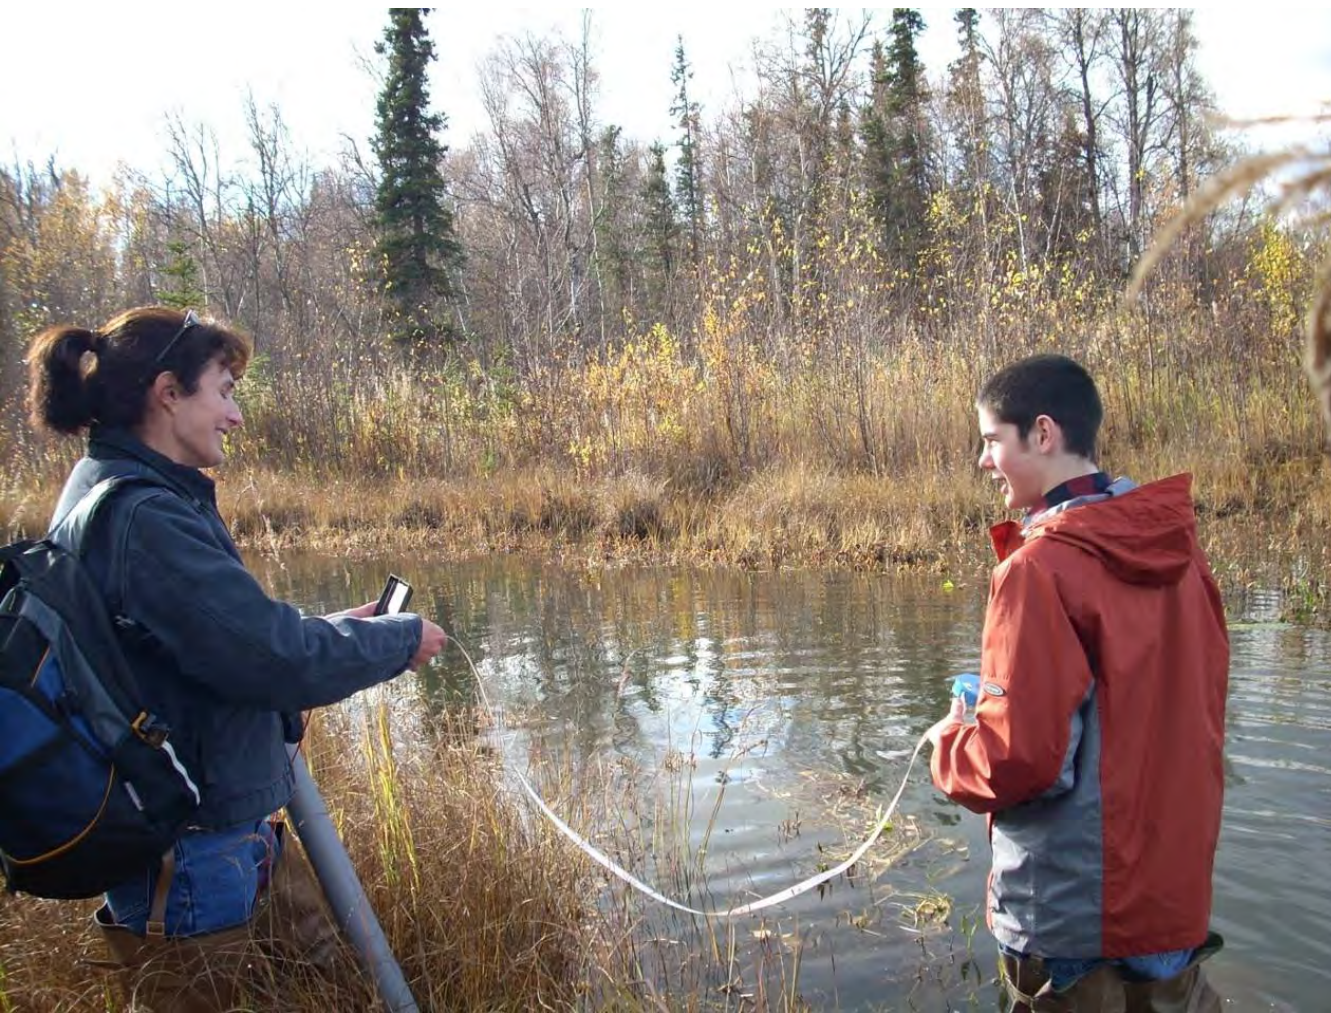
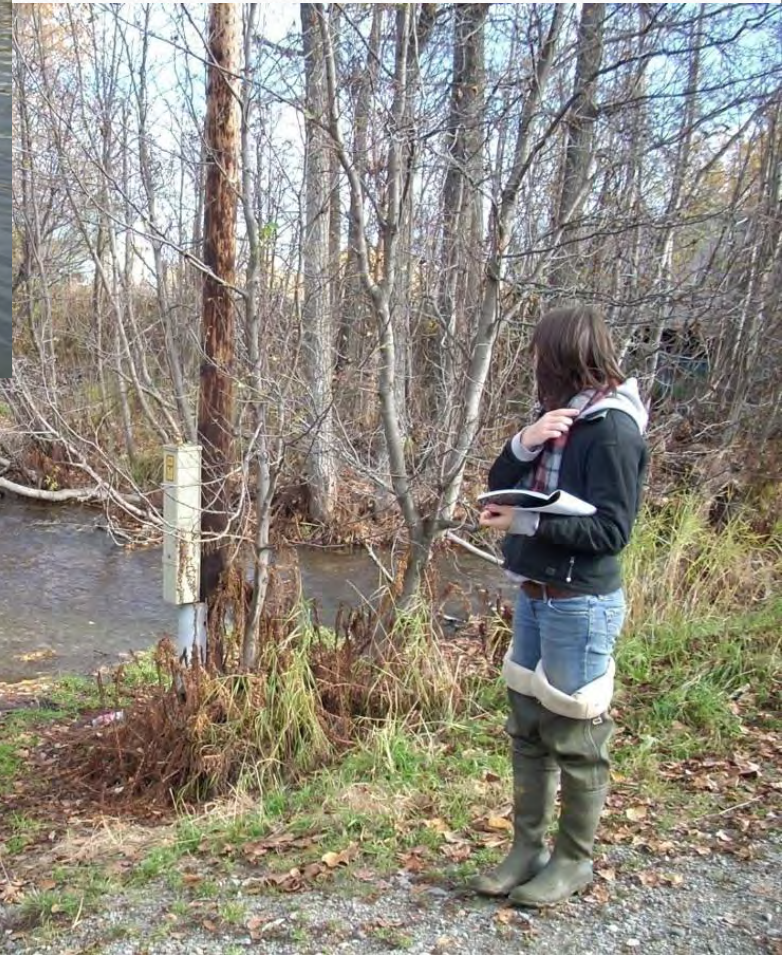
- We will collect water samples at least once a month from five sites along Cottonwood Creek in Wasilla, Alaska. The first site is on Earl Road where Cottonwood Creek runs into Finger Lake. The second site, “Duck Pond”, is at the outlet of Cottonwood Creek from Wasilla Lake. The next site is where Cottonwood Creek runs through the Creekside Plaza parking lot near the Alaska Club. Our fourth site is half a mile down Edlund road. The last site is on Surrey Road. We will monitor these five sites at least once a month for aerobic and coliform bacteria. We will also do water quality testing for alkalinity, ammonia, dissolved oxygen, pH, hardness, nitrate, and phosphate. We also will measure temperature and depth of the water and the air temperature and monitor for foam accumulations.

- The samples for everything except dissolved oxygen will be collected with glass jars (one jar per sample site). To test the water samples for alkalinity, ammonia, pH, hardness, nitrate, and phosphate we will use LaMotte water quality test kits. To test for aerobic and coliform bacteria we will use Hach paddle testers. To measure the bacteria we will dip a double-sided paddle in the water sample, one side measures total aerobic bacteria and the other total coliform bacteria. We will incubate the paddles for 48 hours at 37°C, we then count the colonies on each side of the paddle. Dissolved oxygen samples will be collected in air tight sample bottles that are sealed underwater. The method we will use is called the Winkler Method using LaMotte D.O. test kits where we will fix the samples and then we will titrate each sample to find the amount of D.O. in mgOxygen/L. We will also use data that has been collected by agencies that have been monitoring Cottonwood Creek prior to our project when we do our data analysis. We will collect data for storm drain locations by taking gps waypoints and plotting them on a map. We also have taken gps waypoints for several sites along Cottonwood Creek, including our five sample sites.

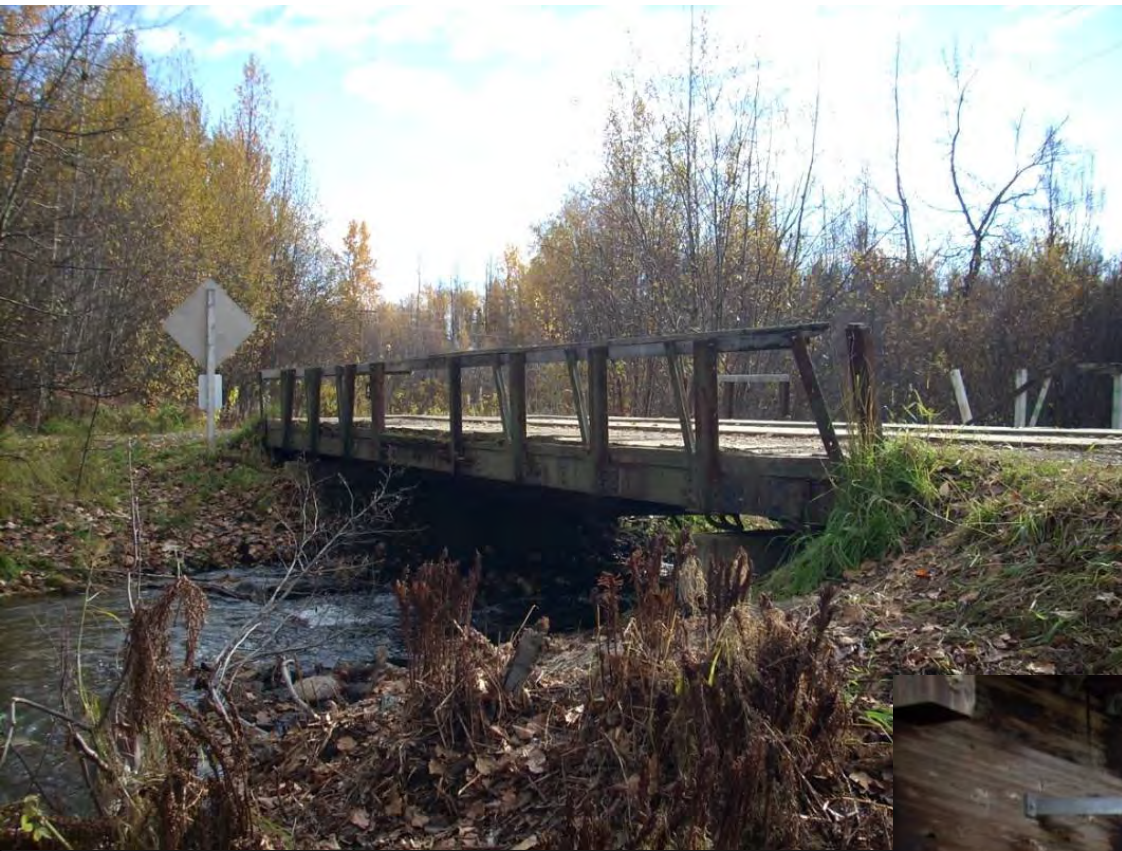
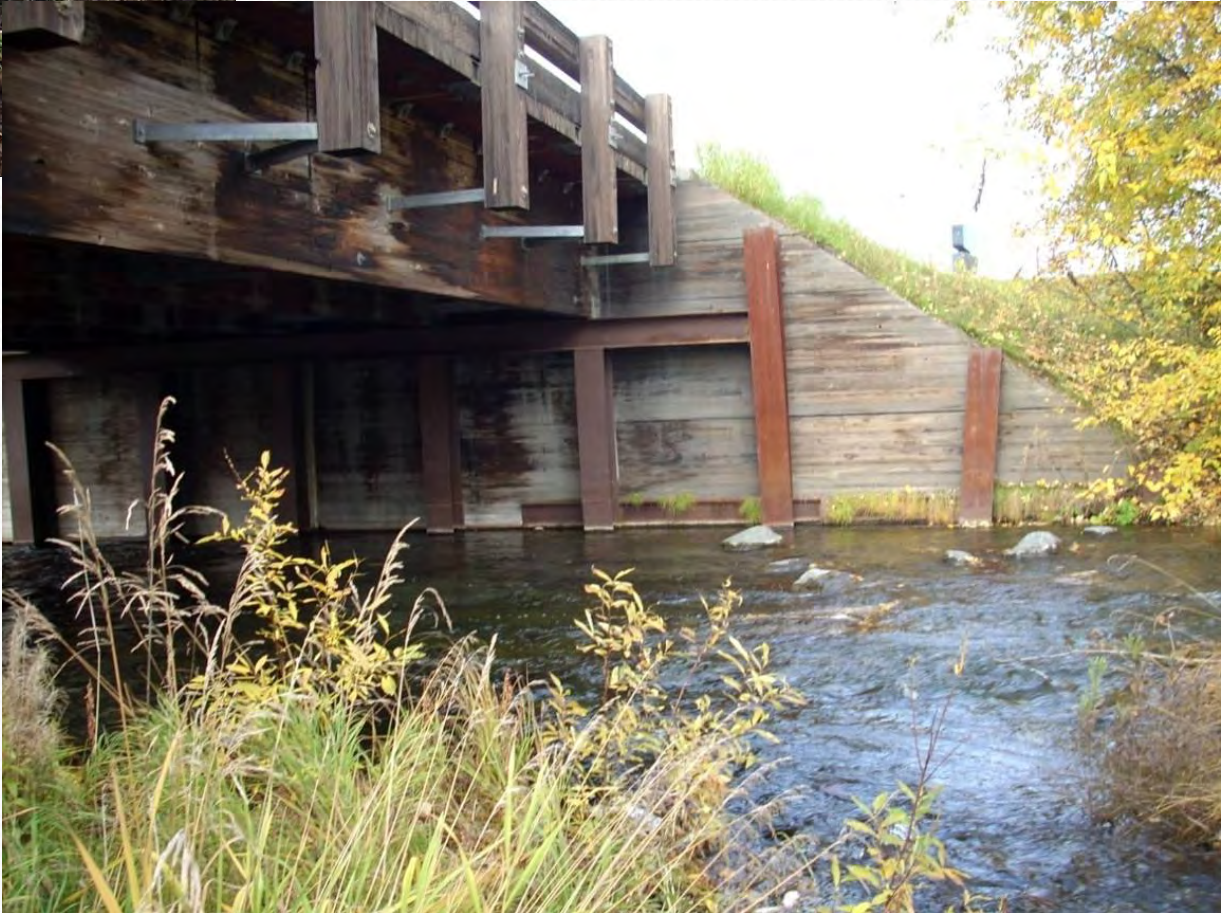
- The data suggests that after rainfall in urban areas there is an increase in both coliform bacteria and total aerobic bacteria. One possible cause of this could be the runoff in these areas.
- (e.g. support or reject it)
