Huslia House Migration Project

Alexander Vent, Barbie Sam
Jimmy Huntington High School

University Alaska Southeast / Department of Natural Sciences, EDGE Program

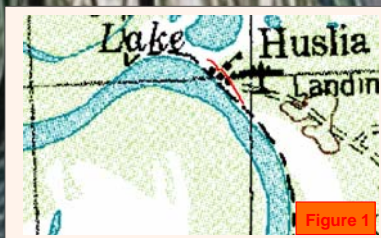
Figure 1

Once we had the track in the GPS we put it in the USGS map (see Figure 1) in the Arc-View Mapping software.

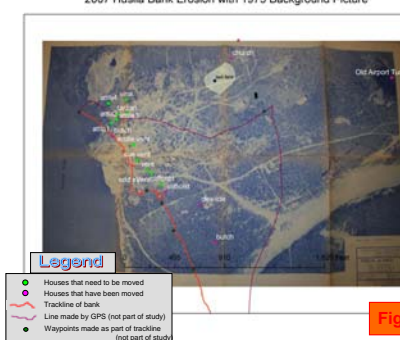
In the 2006-2007 school year we also used GPS units to make a track of the bank of the river and placed it on a 1975 aerial photograph (see Figure 2) to see how much it had caved since that picture was taken.

2007 Huslia Bank Erosion with 1975 Background Picture

As mentioned in the introduction, we wanted to try to stop this erosion. We found this was not an easy task. When the Army Corp of Engineers came to help put cement bags along the edge of the bank there were two different slopes which were used. There was a steep slope and a shallow slope. The bags making the area with a steep slope eroded away and the area with the shallow slope has held together to this day. This shallow slope area can be viewed in Figure 2 as the small peninsula at the middle left of the map.
